# Manhole Inspection Summary

Manhole # S17A1\_006MH

Insp Date: **6/13/08 11:10 AM**

**Location** Address: **1908 wilmington av**

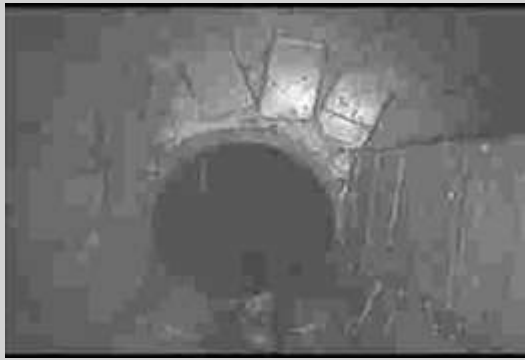
12 O'Clock Outflow

Pipe Height: **8.4** (in.) Rod and Bar (Angled)  
Pipe Material: **Clay** ☐ Pipe Lined  
Invert Depth: **9.80** (ft.) Flow Characteristics: **Slow**  
Deposits: ☒ None ☐ Mud ☐ Sludge ☐ Debris ☐ Grease  
Silt Depth: **0** (in.) Deposits Extent:  
Infiltration: **None** Pipe Seal Cond: **Sound**

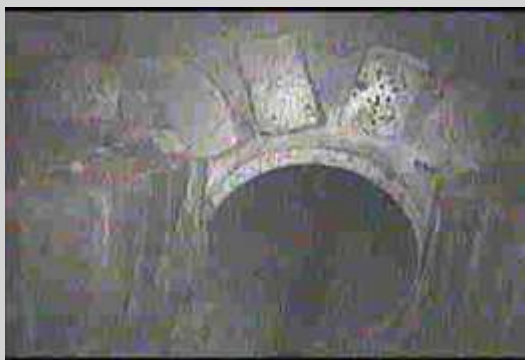
6 O'Clock Inflow

Pipe Height: **8.4** (in.) Rod and Bar (Angled)  
Pipe Material: **Clay** ☐ Pipe Lined  
Invert Depth: **9.51** (ft.) Flow Characteristics: **Slow**  
Deposits: ☒ None ☐ Mud ☐ Sludge ☐ Debris ☐ Grease  
Silt Depth: **0** (in.) Deposits Extent:  
Infiltration: **None** Pipe Seal Cond: **Sound**

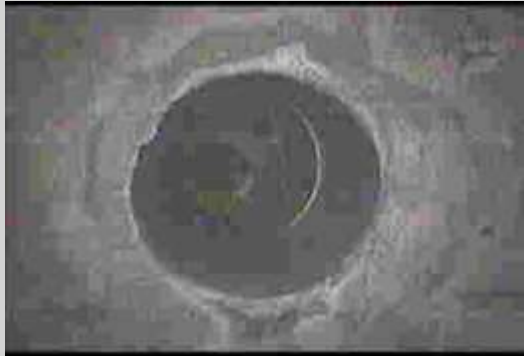
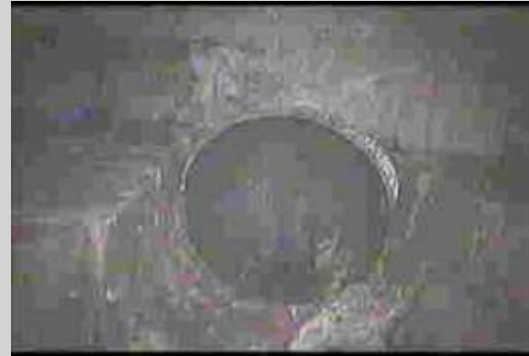
9 O'Clock Inflow

Infiltration: **None** Pipe Seal Cond: **Sound**

Drop Condition: **Open**
